EXHIBIT "A"

Landon Osborne and I (Heidi Daringer) purchased a home at 1840 E street in May of 2005 and we attempted to restore a concrete wall that was falling apart along our alley. Rick Ems of Ems Concrete came out and stated that the wall could not be repaired as the footings were deteriorated and the original bricks (32 inches in length) could not be replaced. This house was built in 1900 and the alley wall looked as if it were put up at that time.

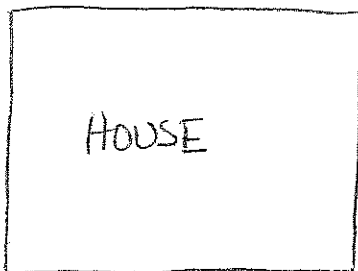
42 ft wrought iron

Back wall = 54 ft

total length = 62 ft

total length = 64 ft

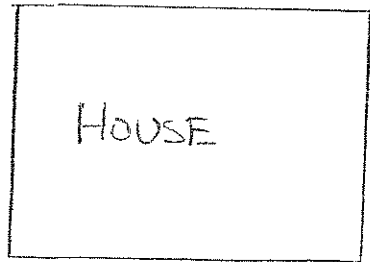
EXHIBIT "B"

if the situation were this is original plan

42 ft wrought iron link to house

Back alley wall = 51 ft

from sidewalk (60 ft) to garage

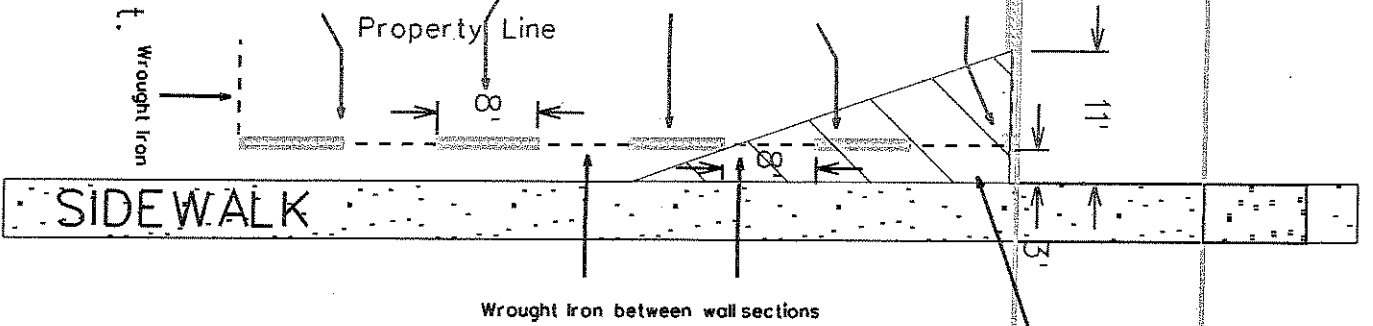
Exhibit "D"

7'9" Block Pillar
** (Existing to Remain)

30" Block Wall with
Wrought Iron on Top

6'6" Block Wall
** (Existing Wall to Remain)

6'2" Block Wall
** (Existing Wall to Remain)

** NOTE: Must be reinforced and
and inspected by Engineer as
per Structural Engineering Report.

Based upon the information gathered at the site, both measured and reported by the contractor, I performed a structural analysis of the 7'-0" high screen walls (Ref. Enclosed Structural Engineering Calculations). My main concern is whether or not these walls and their footings have sufficient strength to withstand the code prescribed 90 MPH (3-second gust) wind load. The results of those calculations demonstrate that these walls do not have sufficient strength or stability to withstand the code wind loads. The footings for these walls were found to be adequate.

Therefore, I recommend the following remedial measures be performed to the three 7'-0" tall CMU walls and the 14" square CMU pier:

2. The 14" square CMU pier will need to be replaced with a new 14" square CMU pier. This new CMU pier should be reinforced with 4- #5 vertical rebars in the corners and #3 ties @ 16" o.c. All four of the vertical rebars will also need to be drilled and epoxy grouted into the top of the footing for an embedment depth of 12". The interior core of this pier should be grouted full with grout having a 28-day compressive strength of $f'_c = 3,000$ PSI and the rebars should be ASTM A615, grade $F_y = 60,000$ PSI.
